CIVIL AERONAUTICS BOARD

ACCIDENT INVESTIGATION REPORT

NORTHWEST AIRLINES, INC.—WINONA, MINNESOTA—AUGUST 29, 1948

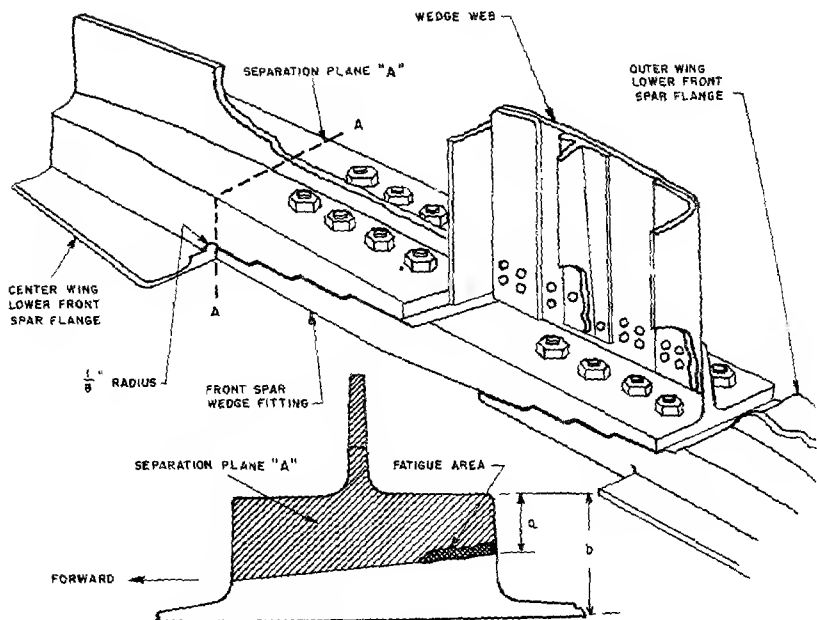
WING ROOT FITTING

The outer wing front and rear lower spar flanges attach to the center wing front and rear lower spar flanges by means of a dihedral wedge as illustrated in the attached drawing. Originally, the spar flanges were bolted directly together, but tests of the prototype airplane demonstrated a need for a greater lateral stability. Therefore, the outer wing was rotated seven degrees upward by means of incorporating the dihedral wedge in the attachment of the outer wing to the center section. It will be noted in the drawing of this part that the attachment ends of the lower spar flanges and dihedral wedge have four steps or vertical increases in thickness. In each step the vertical increase in thickness is approximately 13/64 of an inch, except for the fourth step inboard on the center section spar flange where the vertical increase in the thickness is approximately 3/4 of an inch. The radius in the fillet of these steps is approximately 1/8 of an inch.

Evidence indicated that the outer wing had first separated from the center section in the fillet of the fourth step of the lower front center section spar flange. Examination of this fracture revealed that the separation had started from a fatigue crack approximately 7/8 of an inch long, and 3/32 of an inch deep, the remaining cross section of the material at this point failing from tension.

The particular design of the connection of the lower flange for the front spar of the outer panel to the center panel for the Martin 202 is conducive to high local stress concentration. Hence, it is readily susceptible to fatigue. These high local stress concentrations are due to the following characteristics: the fitting contained fillets of a small radius in the step down of 1/8 inch, there was a large sudden change in cross section in the fourth step down inboard from the attachment, increasing the depth to approximately twice its thickness, and the cross sectional area was designed to a high percentage of the ultimate strength of the material.

6. The fillet of the fourth step inboard of the lower left front center section spar flange revealed a fatigue fracture approximately 7/8 of an inch long and 3/32 of an inch deep. The remaining area failed in tension.

SCHEMATIC SECTION OF SEPARATION OF LOWER FLANGE SHOWING FATIGUE AREA AND ALSO
SUDDEN INCREASE OF DEPTH OF FLANGE "a" TO APPROXIMATELY TWICE THE DEPTH AS INDICATED BY "b"

At the present time the wing root fittings on the Martin 202s are being given frequent and thorough inspections for the development of fatigue cracks, and the operating speeds have been reduced ten percent. In addition, the front center section spar flange has been modified so as to include five steps or vertical increases in thickness to avoid any radical change in cross section. The radius in the fifth step fillet has been increased from 1/8 of an inch to 3/4 of an inch; two bolts have been added, and all parts have been polished. In general the above constitutes present corrective action approved by the Administrator of Civil Aeronautics. It is considered to be temporary in nature, but sufficient for safe operation until 3,000 hours of flight. After 3,000 hours of flight have been accumulated on the aircraft or before, the airplane will be modified at the Martin Company with a permanent correction which involves extensive structural changes to the wing.
